Iminster Town Council, Council Offices, North Street, Iminster, TA19 0DG

Cemetery Lodge, Iminster, TA19 9DX

3 December 2015

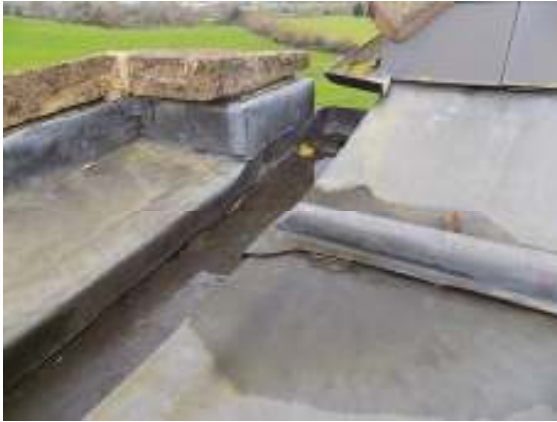
Water ponding to the water gully was noted. Improvements are advised to the fall.

Water to lead gully

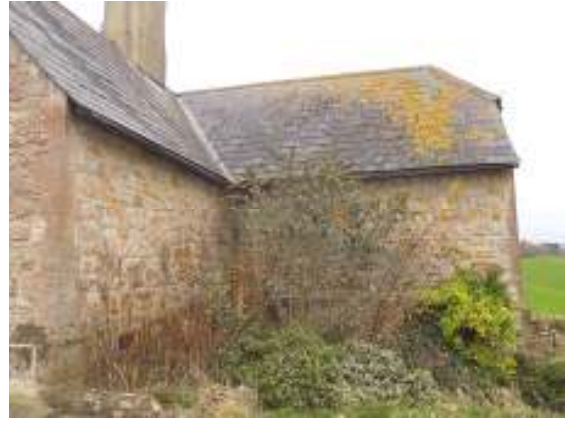
Moss growth is present on roof slopes. This can impede the run-off of rainwater, lead to gutter blockages, and cause water penetration, which in turn may lead to rot or other defects in nearby timbers. Moss growth should be removed on a regular basis.

Moss to roof slope

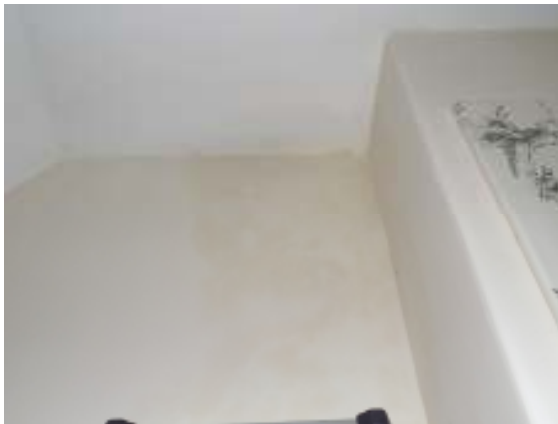
Damp ingress was noted to the chimney breast within the main bedroom. This may be caused by damage to the cement flaunchings at the top of the stack which could not be seen from a ground level inspection.

Damp to main bedroom

As mentioned damp staining was found to the ceiling and surrounds to the chimney breast within the main bedroom. This is thought to be caused by cracking/loose flaunchings to the chimney above. Repairs are required and improvement to decorations.

You are advised to investigate further the condition of the flaunchings and ascertain their condition.

Identify cause of damp ingress to main bedroom.

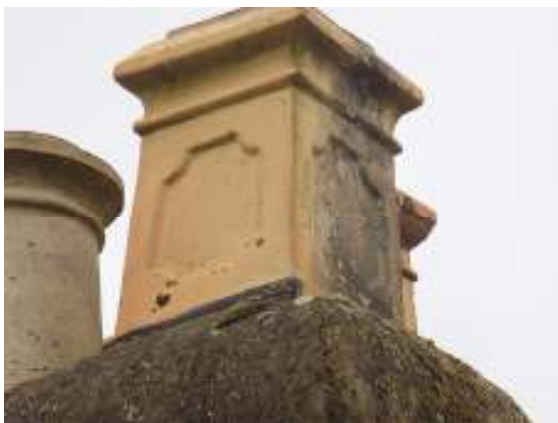
Cracking was noted to the cement render at the top of the stack. Repairs will be required.

You are advised to investigate the top of the stack. Repairs are likely.

Ascertain condition of flaunchings.

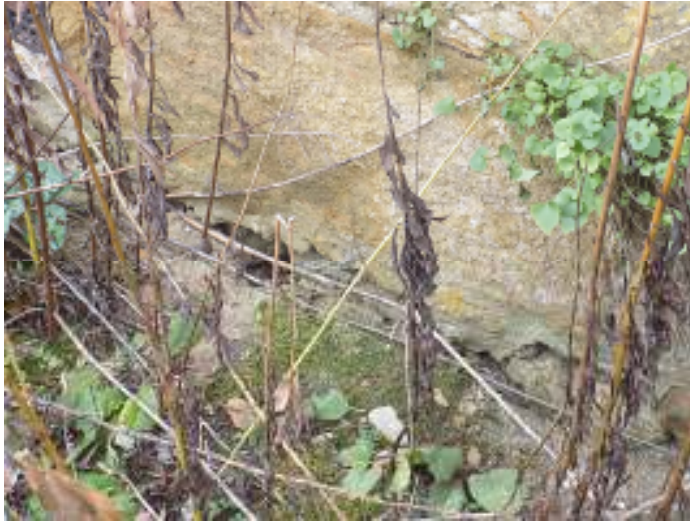
The stone plinth to the base of the main elevations has areas of poor pointing. Re-pointing repairs are advised.

Poor pointing

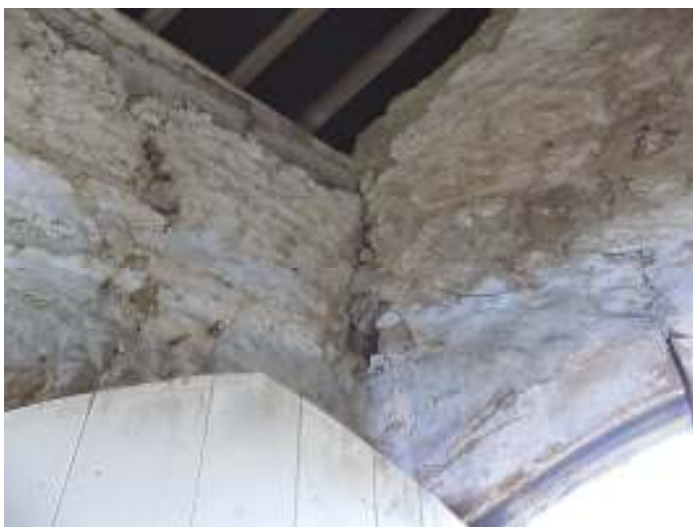
Elevations beneath the covered steps leading down to the cellar are in poor condition. The stone elevations have been painted in the past and this has deteriorated with crumbling stonework beneath. Significant repairs and pointing is required. Adjacent timbers may also be affected and repairs are likely.

Walls to covered area

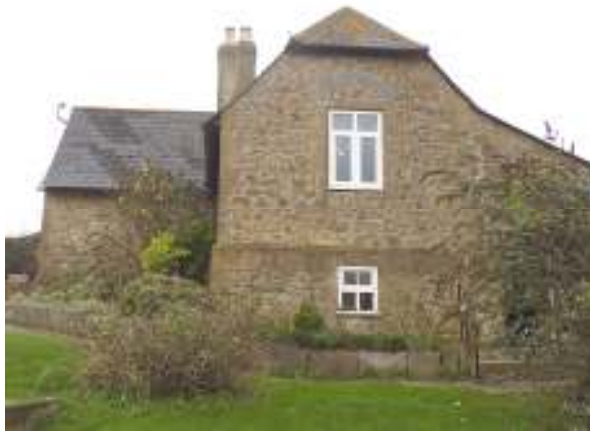
A single glazed window with a timber frame is set to the front of the cellar. This has rotted and replacement is advised.

A timber lintel above the window is also affected by rot and this is likely to require replacement.

Replace rotted timber window and lintel to cellar.

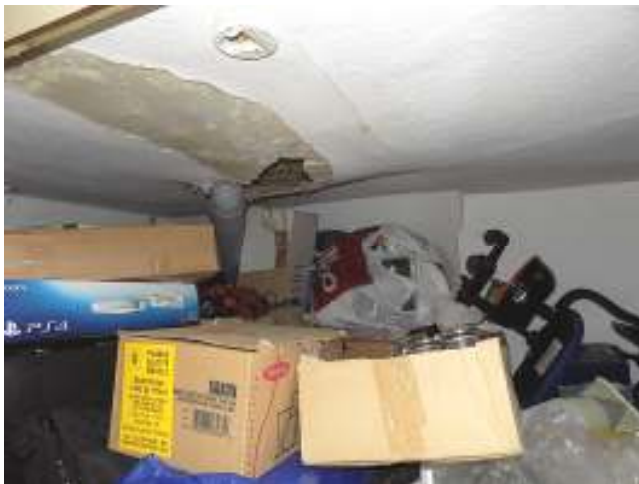
The ceiling within the cupboard in the bathroom has collapsed with plaster detached from the timber laths. Replacement to the ceiling in part will be required, although further damage may be found once this is undertaken.

Collapsed ceiling above  
bathroom

Improve ceiling finishes where necessary.  
Repair defective lath and plaster ceilings.

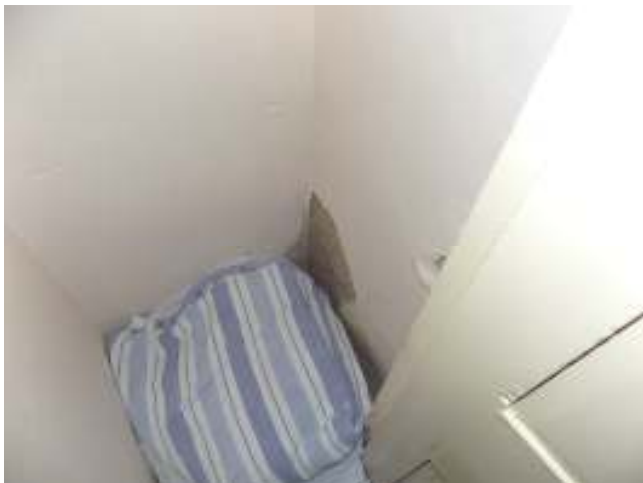
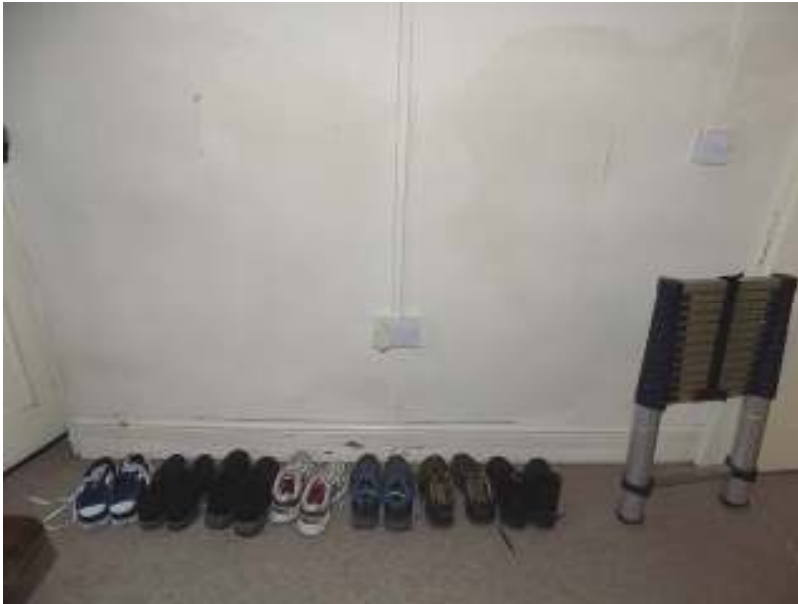
Internally elevations throughout the property have suffered from rising dampness and condensation damage.

Damp meter readings were obtained throughout the property, but particularly within the dining room, main bedroom, bathroom and lobby areas.

Decorative finishes and plaster affected by dampness will require updating once suitable damp preventative measures have been carried out.

Improve plaster and decorative finishes throughout the property.

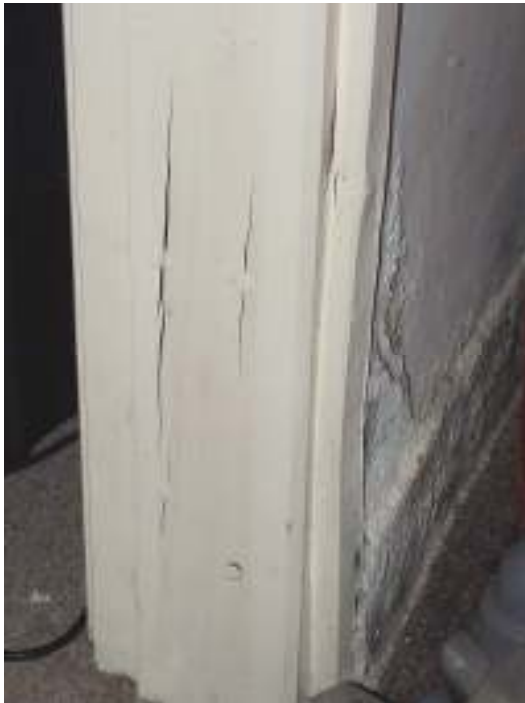
Internal timbers were found in generally poor condition, particularly where dampness has affected internal elevations. Rot was noted to skirting boards and door frames and replacement timbers will be required once all repairs and improvements have been carried out in relation to damp affected areas.

Internal door frame to main bedroom

Replace all damp affected timbers to internal accommodation.

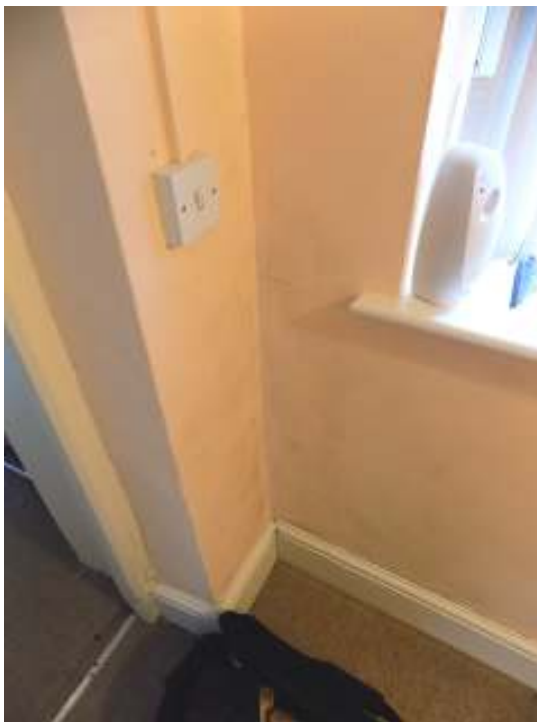
Internal elevations have been affected by condensation staining which is thought to be caused by a lack of heating and poor ventilation.

Further investigation and quotations for damp treatments to internal elevations.

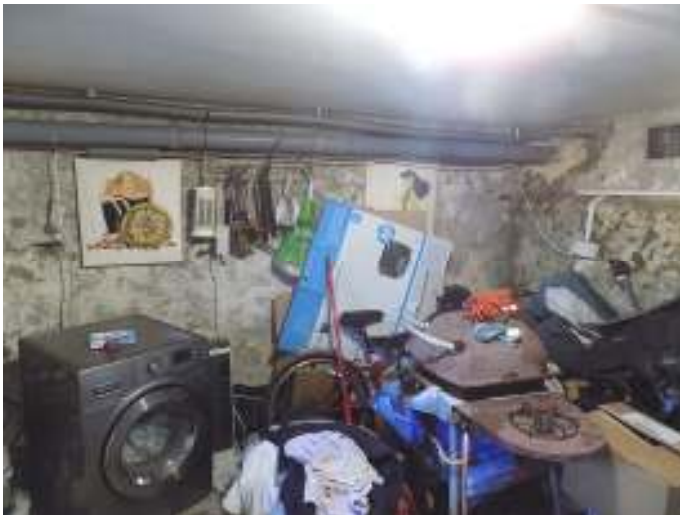
Internal plaster within the cellar was found in poor condition and significant repairs and improvements will be required.

Cellar
